**REMEDICATION OF THE TAR PONDS AND COKE
OVEN SITES
DESIGN AND CONSTRUCTION OVERSIGHT
SERVICES
ENVIRONMENTAL MONITORING
SUMMARY REPORT
August 2011 MONTHLY REPORT
97919-MONTHLY-REP-N-043 R1**

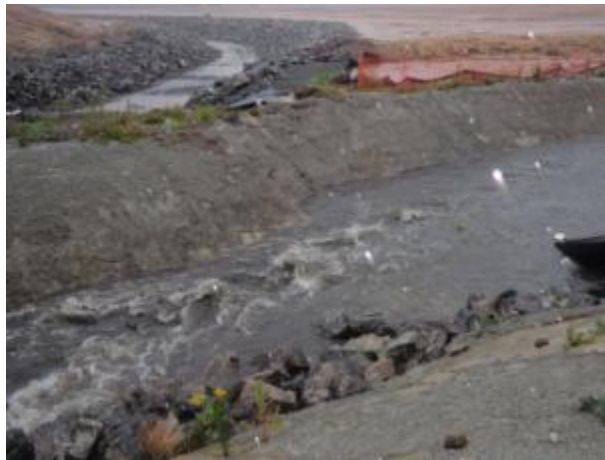
Rain fall on August 23, 2011 caused visibly high turbidity upstream of both the Wash Brook and Coke Ovens Brook pumping stations (see Photo 2-1). At the request of the DE, the Contractor collected turbidity samples upstream of each pumping station for information purposes. Turbidity in Coke Ovens Brook was 64.9 nephelometric units (NTU) and in Wash Brook was 52.6 NTU.

Photo 2-1: Turbid Water in Coke Ovens Brook Entering the Pumping Station

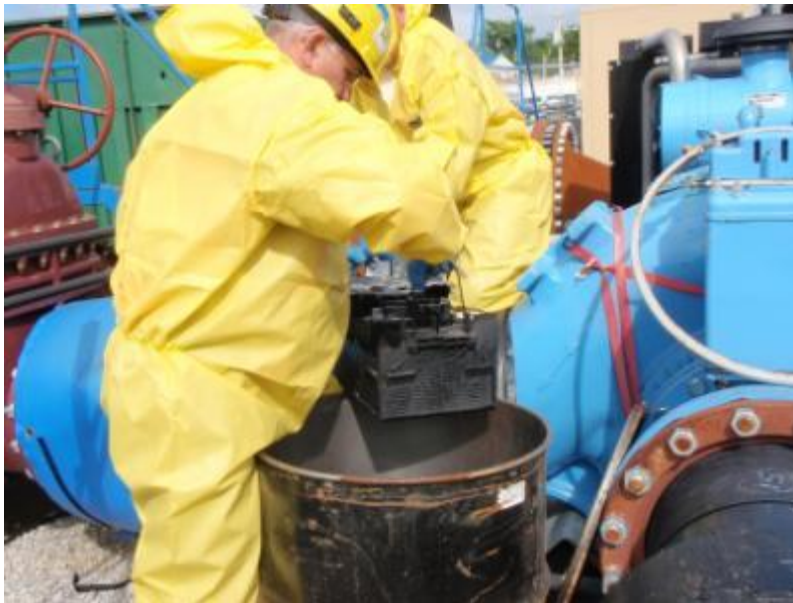
As reported in the previous Environmental Monthly Summary Report, a leak from the battery on pump 81017 at Wash Brook was observed on July 31, 2011. Impacted materials were contained and removed on immediately. On the following day, August 1, 2011, the battery was removed from site and disposed of properly.

Photo 2-2: Removing Damaged Battery from Pumping Station

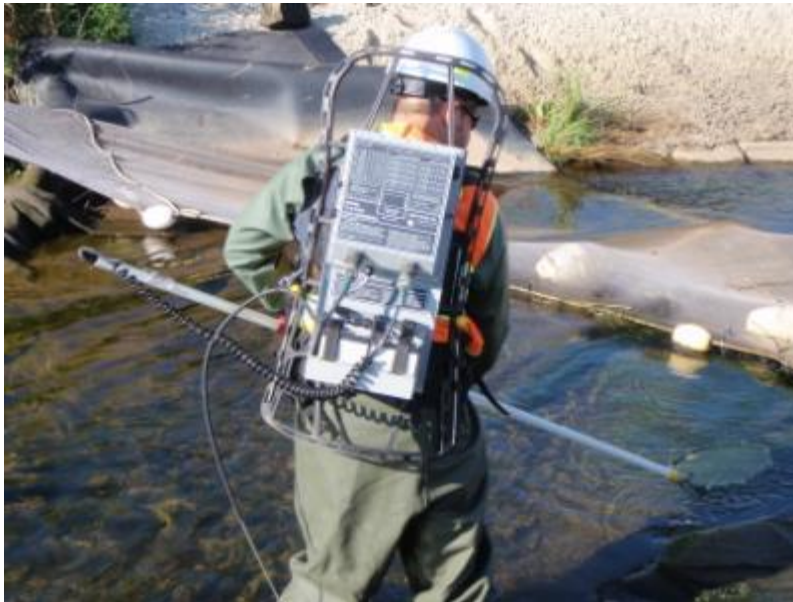
Photo 2-3: Fish Removal Activities in Coke Ovens Brook

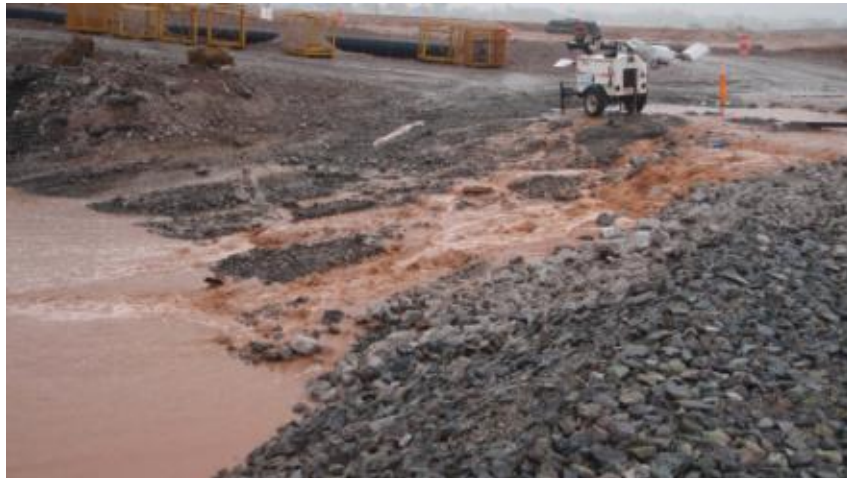
On August 23, 2011 heavy rain resulted in the release of highly turbid water and flooding throughout the site. Water overflowed a berm in the Phase I area and began to flood the Ferry Street sump with red clay

laden water. (See Photo 3-1) The Contractor turned off the Ferry Street pump until the rain stopped and the clay impacted water settled out and was removed by the TP7 Contractor, described in Section 4.2. A large amount of water discharged from the CBRM combined storm/sewer outfall, causing the southwest sump to overflow. (see Photo 3-2). The channel under construction was also flooded this day. The Contractor stopped all work activities until the rain and flooding subsided, and focused solely on water management for the remainder of the day.

Photo 3-1: Clay Impacted Water Flowing into Ferry Street Sump

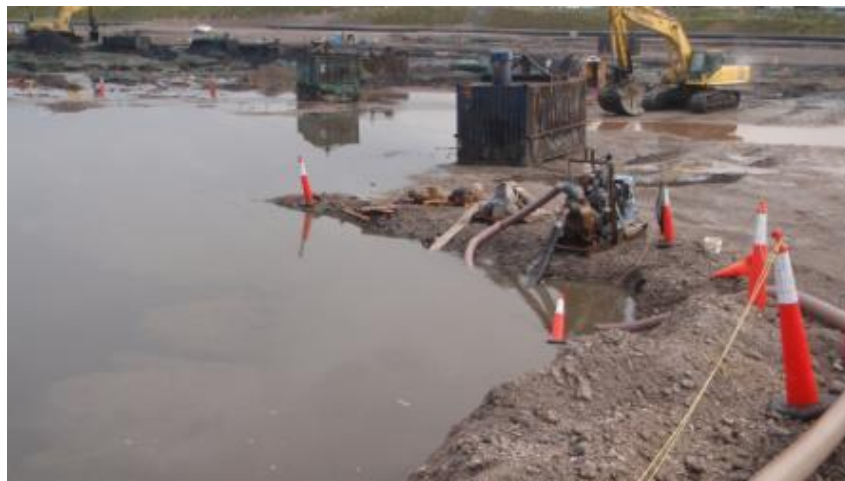
Photo 3-2: Sewage Impacted Water Overflowing the Southwest Sump

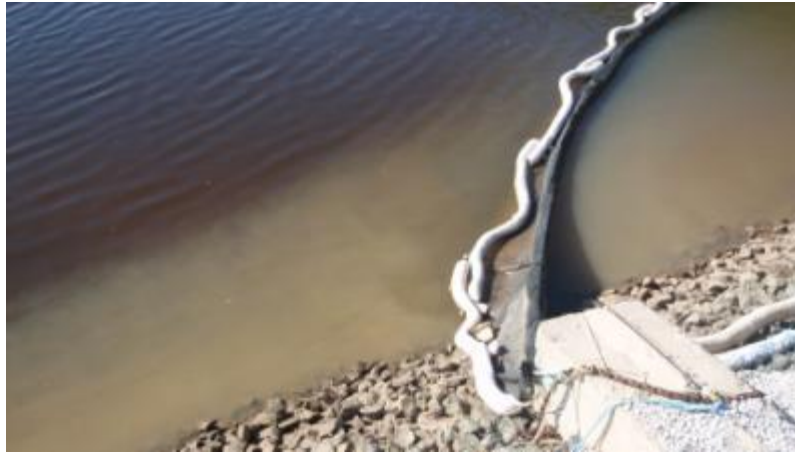
Throughout August, 2011 turbid water was observed on a daily basis around the Phase III release point. The Contractor/DE noted that the rise in turbidity was directly influenced by tidal action. Turbidity would increase as the tide became low, and decrease shortly after starting to rise again. The turbidity was normally a white/grey colour, indicating that water was removing fines from the slag and rock in the Narrows road (see Photo 3-3). This cycle was monitored daily throughout August, 2011.

Photo 3-3: Turbidity at Phase III Release Point

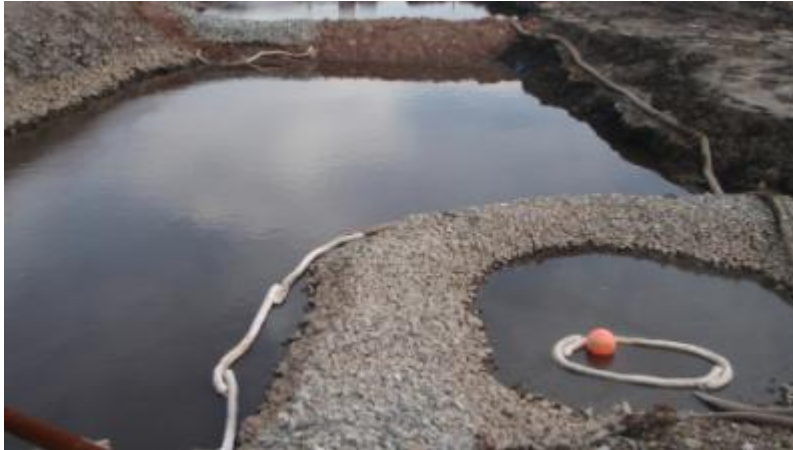
connecting the northeast and Narrows sumps. A second rock check dam was built around this pump to further help settling of solids (see Photo 3-4). On occasions of high rain an extra pump was added in the northwest corner of the sump.

Photo 3-4: Northeast Sump

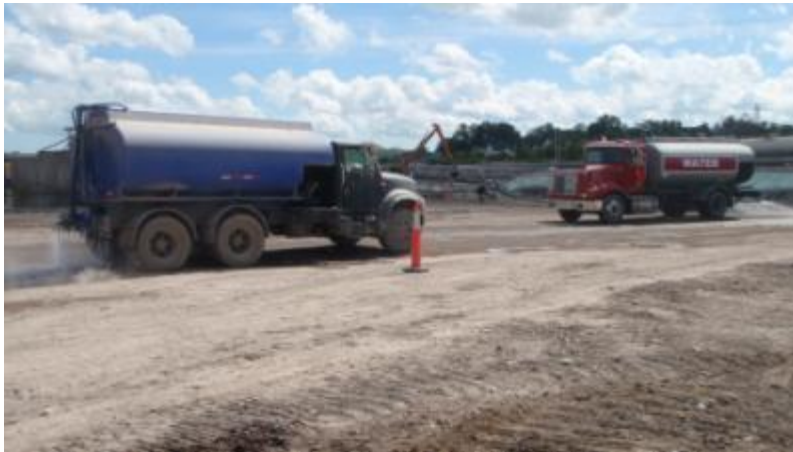
Access roads were dry and dusty on most days throughout August, 2011. On these days, the Contractor deployed a water truck on the TP6B working area. This truck along with the Agency's water truck kept the roads wet to mitigate dust. The Contractor also utilized a front end loader to scrape black sediment from site roads on all work days in August, 2011.

Photo 3-5: Water Trucks Deployed for Dust Control

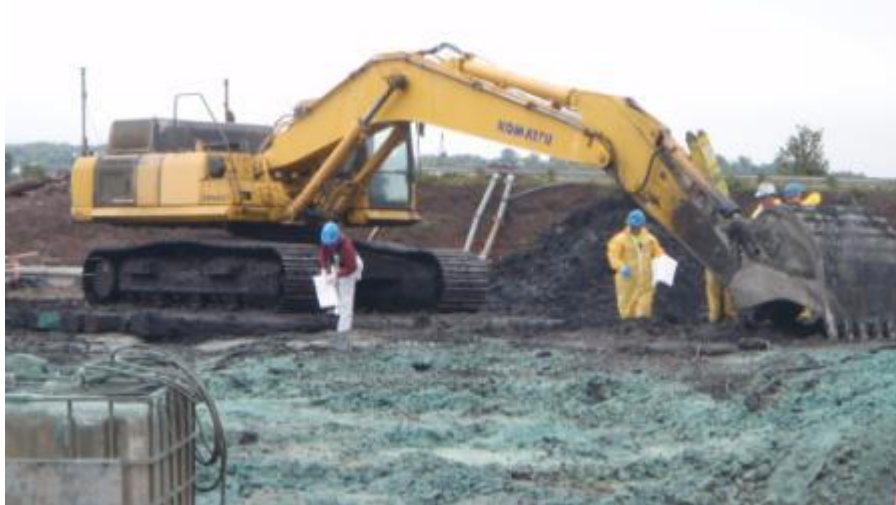
In the morning of August 16, 2011, a hydraulic hose broke on an excavator while mixing cell #664 on the east side of the North Tar Pond (see Photo 3-6). The operator immediately shut down the excavator and the majority of the leaked hydraulic fluid spilled into the cell. The Contractor approximated that the amount of the hydraulic fluid in the range of 20 - 30 liters based on the amount of fluid put back into the excavator upon completion of hose repair. While the excavator was being repaired, oil absorbent pads

Photo 3-6: August 16, 2011 Hydraulic Fluid Leak

were laid to contain further spills. The spilled fluid was mixed into the cell upon repair of the excavator hydraulic hose. The Contractor submitted a spill report for this incident.

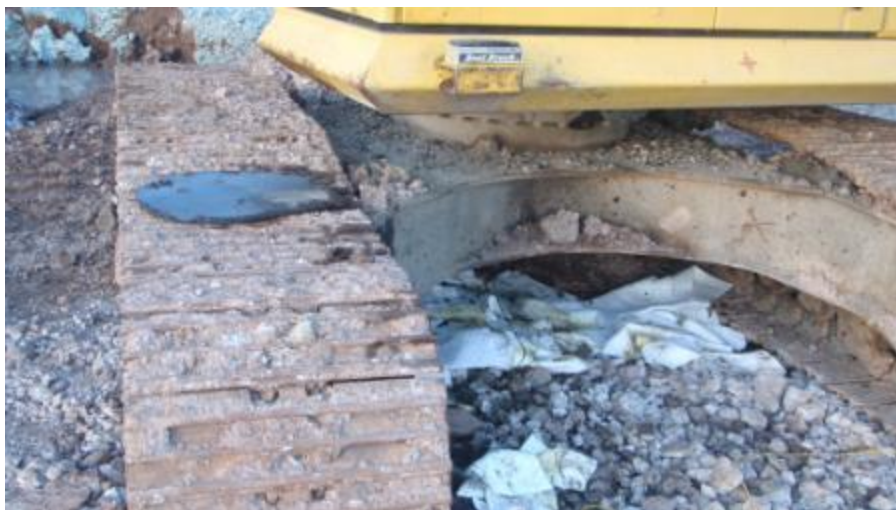
On the afternoon of August 19, 2011 the TP6B Contractor reported a spill in the channel excavation near station 1+100. Product was spilled onto clean slag. Oil absorbent pads were placed under the excavator to contain product from migrating (see Photo 3-7). The excavator was fixed the following work day, and the impacted slag was removed and set aside to be mixed into a future cell. When the hydraulic oil was replaced in the machine, it was estimated that between 80 and 90 litres of fluid were spilled.

Photo 3-7: August 19, 2011 Hydraulic Fluid Leak

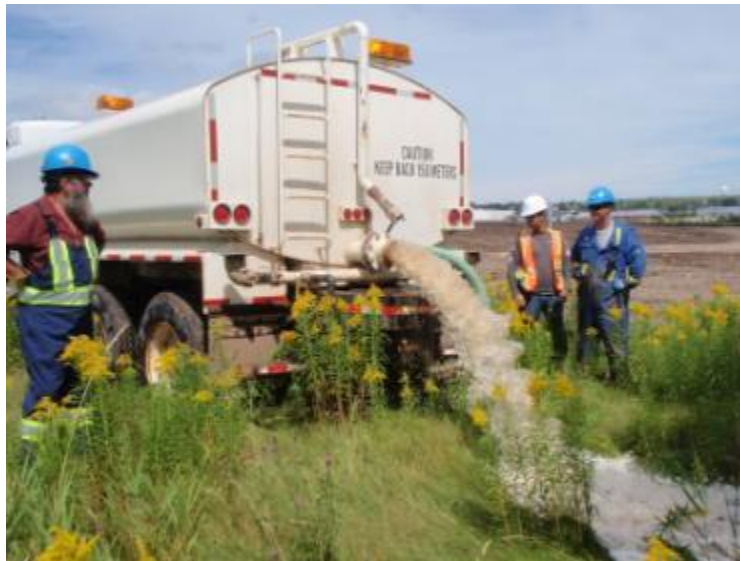
The berm located near the Phase I access ramp breached on August 23, 2011 releasing clay laden water into TP6B Contractor's sump. The TP6B Contractor shut off their pump immediately and the TP7 Contractor deployed a water truck to remove impacted water from the sump. The TP7 Contractor released the water into the grassy area on top of the former landfill for infiltration (see Photo 4-1).

Photo 4-1: Discharging Clay Laden Water to the Former Landfill for Infiltration

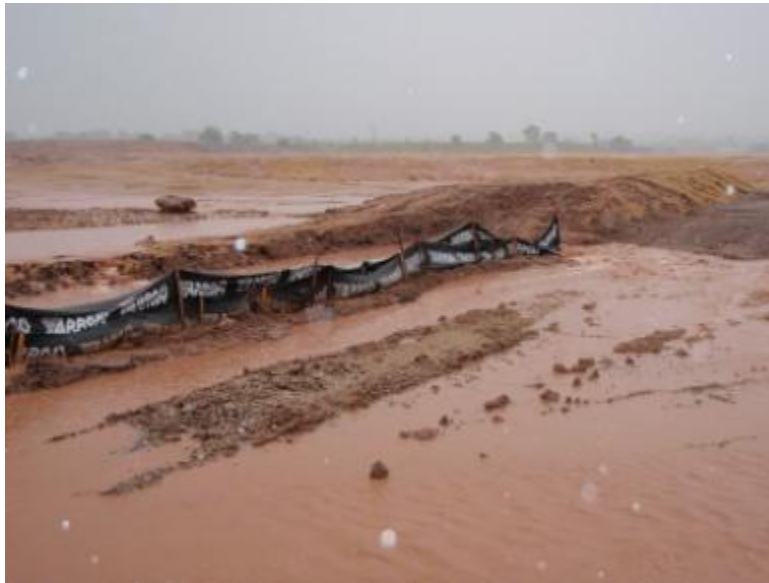
As mentioned in Section 4.2, the berm located near the Phase I access ramp breached on August 23, 2011 releasing clay laden water into TP6B Contractor's sump (see Photo 4-2).

Photo 4-2: Clay Laden Water Enters TP6B Sump Area

The pump was turned off immediately and a water truck deployed to remove impacted water from the sump. The following day the TP7 Contractor repaired the damaged berm and raised it by two (2) feet (ft)

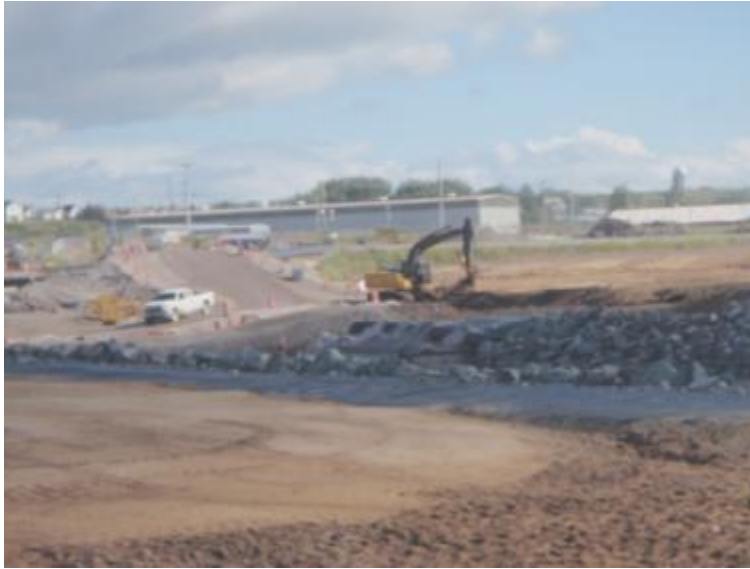
Photo 4-3: Reconstructing Berm near Phase I Access Ramp

to better prevent future breaches (see Photo 4-3). GeoPerm was applied to the berm on August 26, 2011. On August 23, 2011 the DE issued NCR-TP7-008 Clay Laden Water Breach, which outlines the incident. The Contractor had not responded to the NCR before the end of the reporting period.

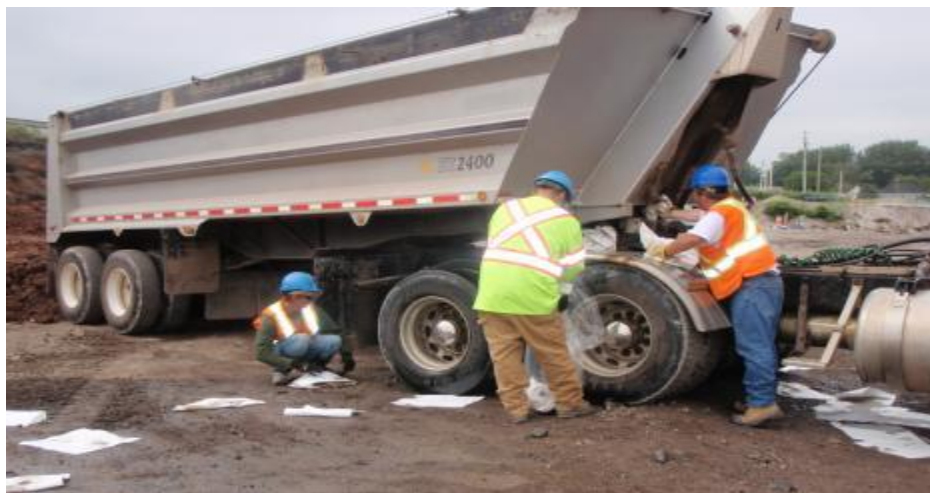
Approximately 10 L of hydraulic fluid released from an End Dump Trailer when a hydraulic hose ruptured on August 19, 2011. The truck operator stopped immediately, and absorbent pads were used to contain spill (see Photo 4-4). The affected ground beneath the truck was scraped up, and was placed in hazardous waste bags along with oil absorbent pads for off-site disposal.

Photo 4-4: Absorbent Pads Used to Contain Hydraulic Fluid Leak
