**REMEDICATION OF THE TAR PONDS AND COKE
OVEN SITES
DESIGN AND CONSTRUCTION OVERSIGHT
SERVICES
ENVIRONMENTAL MONITORING
SUMMARY REPORT
October 2011 MONTHLY REPORT
97918-MONTHLY-REP-N-045**

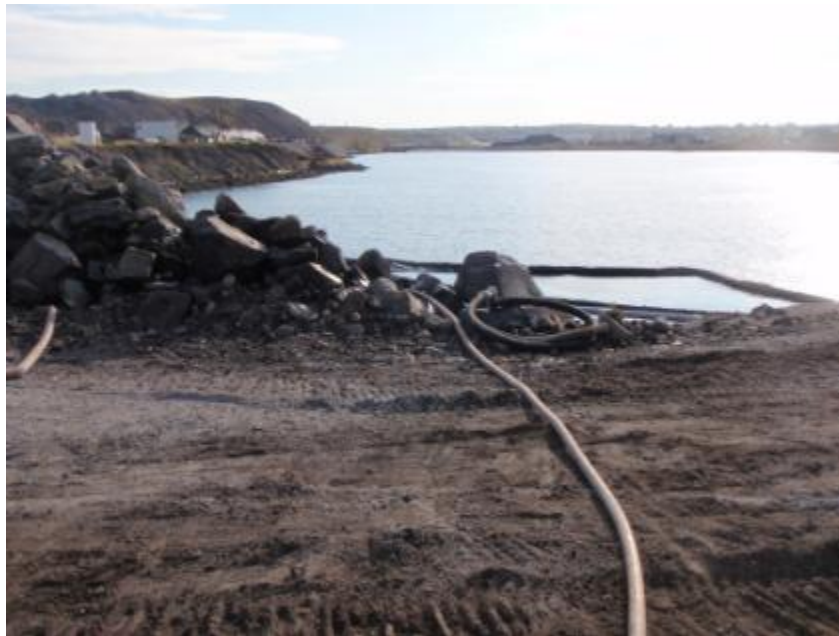
As they continued work on the BPDS, the Contractor commenced dewatering tidal water inflow from the discharge cells on October 18, 2011. The Contractor decanted water onto armour stone in the northeast corner of Phase III pond, where they had previously installed a double row of silt curtains and an oil absorbent boom (see Photo 2-1). This activity continued as required throughout October 2011 and did not encounter any erosion or turbid water issues.

Photo 2-1: Decanting BPDS Cell into Northeast Corner of Phase III

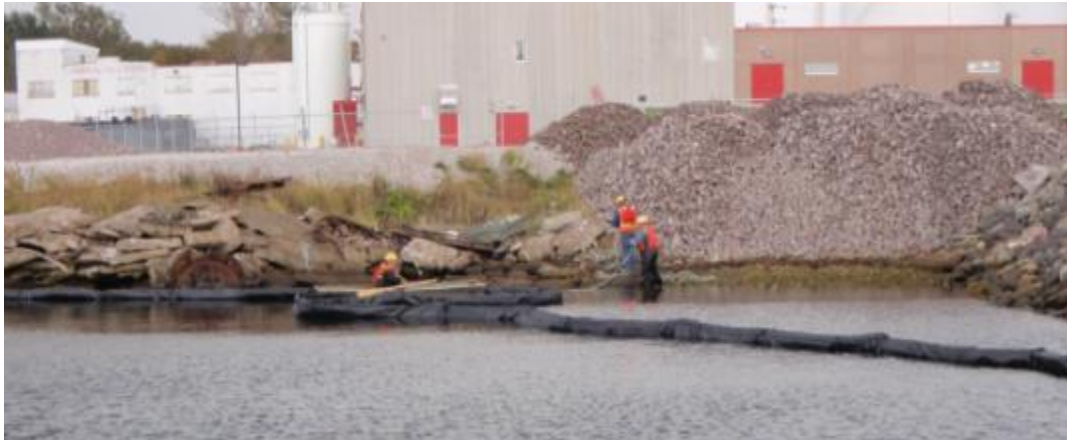
On October 18, 2011 in preparation for pumping tidal water out of the BPDS a double row of silt curtains and an oil absorbent boom were installed on the southeast side of Battery Point. The Contractor also installed a single silt curtain and an oil absorbent boom on the west side of Battery Point in preparation for constructing a crane pad on that side (see Photo 2-2). Wayne Williams, the Contractor's fish specialist, supervised the installation of the silt curtains to verify they were installed in from the shoreline outwards to devoid the area within the silt curtain of fish. These silt curtains and oil absorbent booms were monitored and maintained throughout October 2011.

Photo 2-2: Silt Curtain Installation on West Side of Battery Point

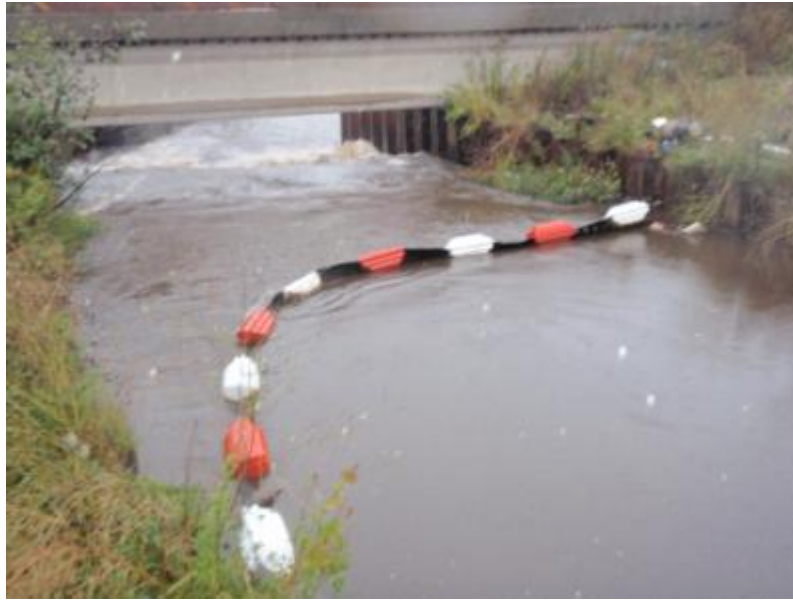
On October 5, 2011 after heavy precipitation in the area, high turbidity was observed in the North Tar Pond north of the NDS and at Battery Point. The Contractor performed turbidity testing upstream along Coke Ovens Brook and Wash Brook as upstream samples and it was noted that those upstream sources had elevated turbidity levels and therefore the cause was an off-site source (see Photo 2-3). The Contractor also identified highly turbid water from the outfalls that discharge into the main Channel near Wash Brook (see Photo 2-4). The Contractor increased the frequency of testing throughout that day and the next.

Photo 2-3: High Turbidity in Wash Brook Upstream of Site

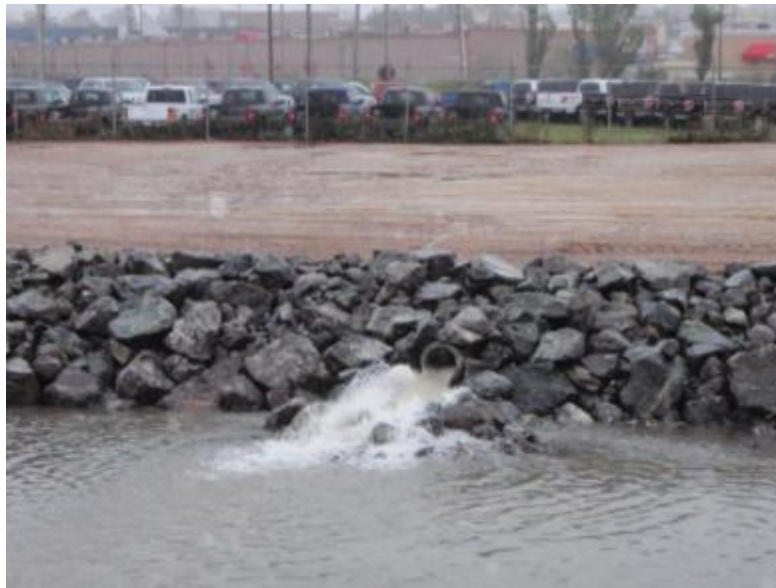
Photo 2-4: Turbid Water Discharging into the Main Channel via Outfall near Wash Brook

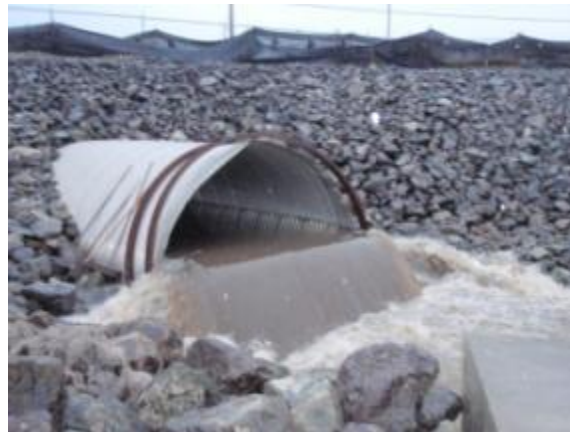
A storm surge occurred on October 5, 2011 forcing the Contractor to raise the fish screens at Wash Brook, and causing the fish screen at Coke Ovens Brook to dislodge from the culvert and breach (see Photo 2-5). After high flows subsided, on October 7, 2011 both fish screens were put back into place. On October 12, 2011 the Contractor's fish specialist performed fish removal activities in Coke Ovens Brook; he captured 18 fish and relocated them upstream of the fish screens.

Photo 2-5: Fish Screens Breached in Coke Ovens Brook

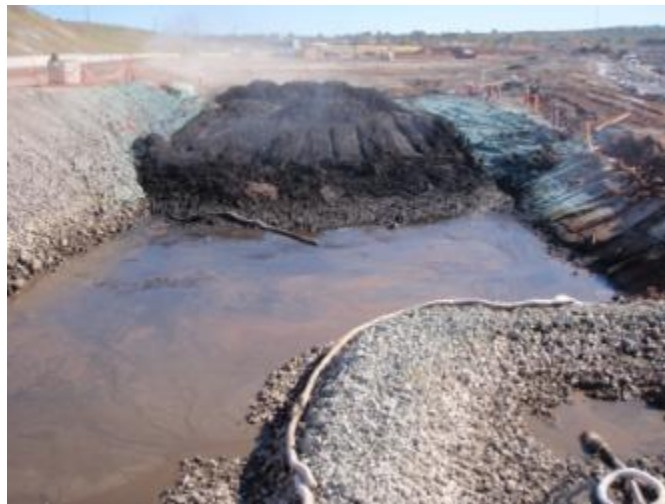
On October 12, 2011 the Contractor placed untreated material into the southern section of the northeast sump and breached the clay berm, pushing the material into the standing water in the northern section of the sump (see Photo 3-1). This activity contradicted the response given to RFA-TP6B-061. The RFA was reissued to the Contractor on October 14, 2011 requesting further explanation of these activities and a solution. The Contractor removed the untreated sediment and restored the clay berm in this sump on October 17, 2011. On October 24, 2011 the Contractor responded to the revised RFA outlining the corrective actions taken.

Photo 3-1: Dumping Impacted Material in the North Portion of the Northeast Sump

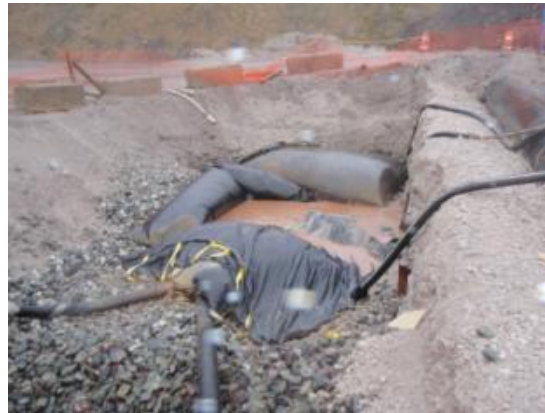
On October 5, 2011 heavy rains caused minor flooding in parts of the site. Clay laden water from TP7 activities flowed into both the Ferry Street and southwest sumps. The TP6B Contractor pumped the turbid water to the Narrows infiltration pit, instead of the northeast settling area which is designated for turbid water. This resulted in one (1) of the sediment bags in the infiltration pit rupturing and clay laden water entering the Phase III pond. This incident exposed deficiencies in the Contractor's environmental controls such as a faulty silt curtain and ruptured sediment bags, shown in the Photos 3-2 and 3-3, respectively. On October 11, 2011 the Contractor received NCR-TP6B-032 Water Management Implementation for failure to comply with their CEPP. They responded to the NCR on October 25, 2011

stating that the TP7 Contractor was responsible for the incident, as they failed to control the water running off the clay in the South Tar Pond, and in the southwest corner of the North Tar Pond. They also stated that allowing the clay-laden water to enter their northeast settling pond would jeopardize their operations, and that aperture of the filter bags in question would not filter out the much smaller clay sized particles. Regardless of these points, the Contractor did not follow the protocols stated in their work plan.

Photo 3-2: Turbid Water Flowing Through Ruptured Sediment Bags

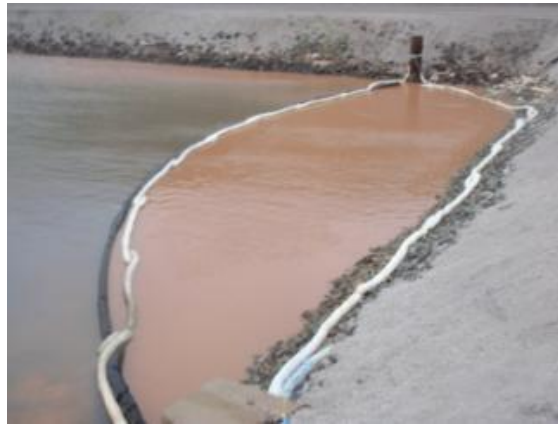
Photo 3-3: Turbid Water Escaping Around Silt Curtain

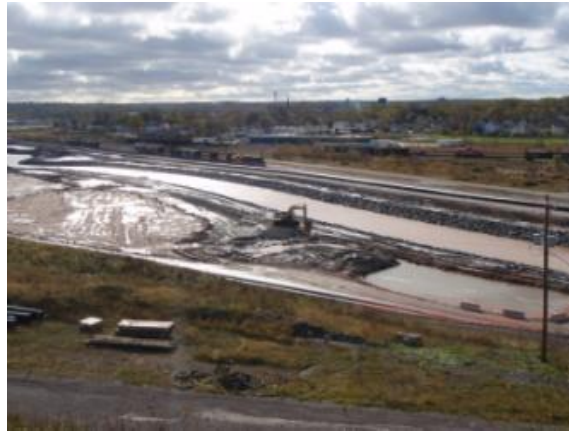
On October 30 and 31, 2011 heavy rains coupled with a storm surge of 1.9 m resulted in flooding of the Channel (see Photo 3-4). It was deemed that the main cause was increased flow of the Coke Ovens Brook overwhelmed the pump around system. This water flowed into the Phase I Channel and breached the berm at Station 0+630. All TP6B pumps were shut off until the Contractor was given direction on how to deal with this water. NSE gave permission to pump this water directly over the Narrows to prevent further flooding (see Photo 3-5). Most of the water was drained on October 31, 2011, while the remainder of the water at Station 0+650 was pumped into the Phase I Channel at the request of the STPA.

Photo 3-4: Flooding of the Phase I Channel

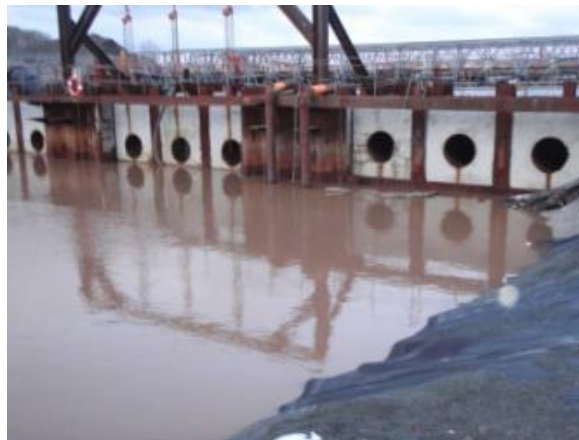
Photo 3-5: Pumping Over the Narrows Structure

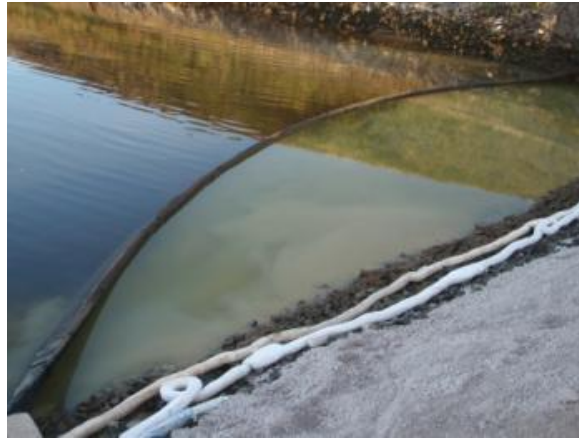
Throughout October 2011 turbid water was occasionally observed on a daily basis around the Phase III release point. The Contractor/DE noted that the rise in turbidity was directly influenced by tidal action. Turbidity would increase as the tide became low and decrease shortly after starting to rise again. The turbidity was normally a white/grey colour, indicating that water was removing fines from the slag and rock in the Narrows road (see Photo 3-6). This cycle was monitored daily throughout October 2011.

Photo 3-6: Low Tide Turbidity at the Phase III Release Point

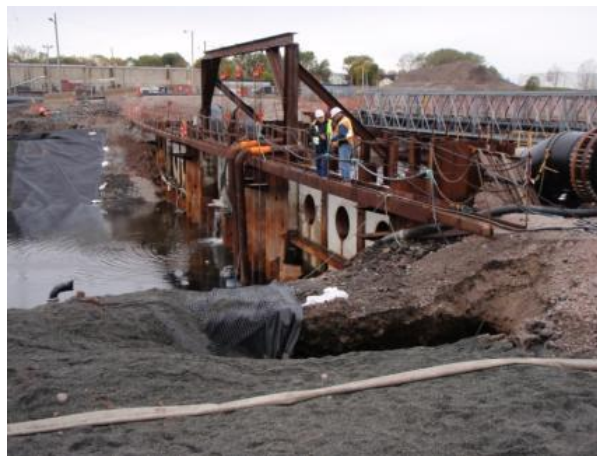
On Friday October 28, 2011 tidally influenced groundwater began flowing into the channel near the Narrows structure. This water resulted in erosion of untreated material under the TP6A crane pad and caused a surface collapse as the sediments were deposited into the channel (see Photo 3-7). The Narrows pump was immediately shut off and the channel began to flood with black water. Water was pumped from the Channel into the northeast sump to reduce the impact of the flooding. An area around the collapse was excavated and concrete plug was poured with the intention of reducing the amount of water that would enter the Channel during high tide. Slag was also placed in the hole that entered the Channel to act as a plug. Oil absorbent booms were installed in the Channel to reduce the impacts of migrating oily water. Extra oil absorbent booms were also installed in the northeast sump. Environmental monitors were onsite during each high tide event over the course of the weekend. The Contractor also had personnel onsite to monitor and maintain pumping.

Photo 3-7: Seawater Intrusion and Collapse

On the night of October 28, 2011 during high tide, water began to flow into the Channel again at a rate equivalent to that observed earlier in the day. The concrete plug was unsuccessful at stopping the water. In addition to this, a portion of the slag placed in the Channel to hold back the water had eroded away and slid around the pump used to manage the water. Labourers installed additional pumps to substitute for the lost pump while it was under repair.

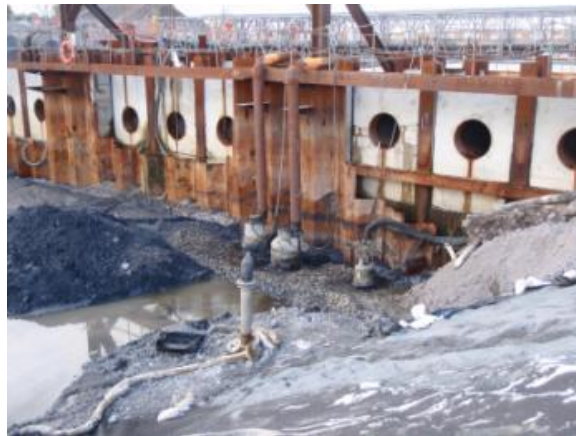
Photo 3-8: Rock Dams Constructed around Pumps at the Narrows

The following morning the Contractor was onsite before high tide and used an excavator to remove slag and sediments from around the pumps. A rock check dam was built around the pumps to prevent material from building up around the pumps again (see Photo 3-8).

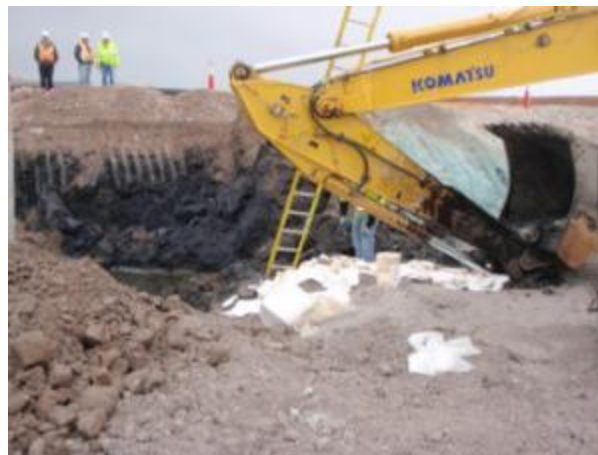
In the afternoon of October 25, 2011, a hydraulic hose broke on an excavator while removing previously S/S'd material and shaping the berm at Stn 0+650 (see Photo 3-9). Approximately 40 litres of fluid was released. When the spill occurred the equipment was shut down and the Contractor placed oil absorbent pads on and around the affected area. Once the excavator was repaired, the impacted material was removed and incorporated into future S/S cells. The Contractor submitted a spill report to the DE summarizing the incident.

Photo 3-9: Hydraulic Oil Spill

Date (dd/mm/yy)	Nature of Spill	Quantity	Location	Release to Env?	Contractor Response
25/10/2011	Hydraulic fluid; leaked from broken hydraulic hose on excavator.	40 l	South of Ferry Street adjacent to pressure relief well #31	Yes	The operator and labourers immediately put oil absorbent pads down in an effort to contain as much of the spill as possible. The hydraulic hose was replaced on the same day. The impacted sediments were gathered up and placed in the exclusion zone to be included in a stabilized cell.

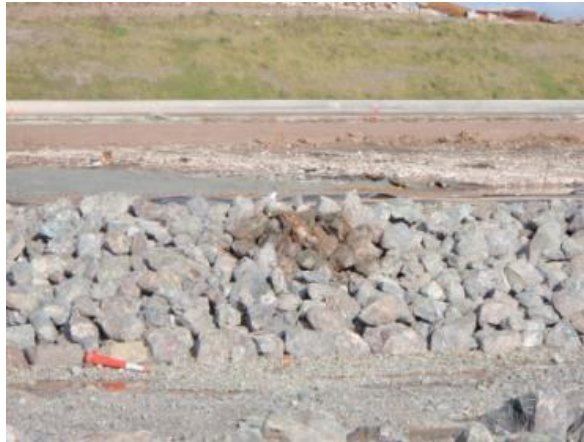
On October 21, 2011 the Contractor decanted highly turbid pooled rain water from the Phase II clay stockpile area onto Phase II channel riprap (see Photo 4-1). The DE notified the Contractor that this was not an appropriate course of action. The Contractor shut off the pumps upon notification from the DE. The following day, the TP7 Contractor completed decanting this water by directing the discharge through filter bags prior to discharging onto rip rap. As a response to the October 21, 2011 pumping activities, the DE issued NCR-TP7-010 Water Management and Erosion Control, stating that during pumping activities there were no environmental controls and no one monitoring the discharge. The DE also pointed out that while no water was flowing in the channel at the time of pumping, in the future water will flow down this Channel and the impact of TP7 pumping sediments into the channel will affect its performance in the future. The Contractor did not respond to this RFA prior to the end of the reporting period.

Photo 4-1: Hose Discharging Turbid Pooled Phase II Rain Water into Un-Finished Channel

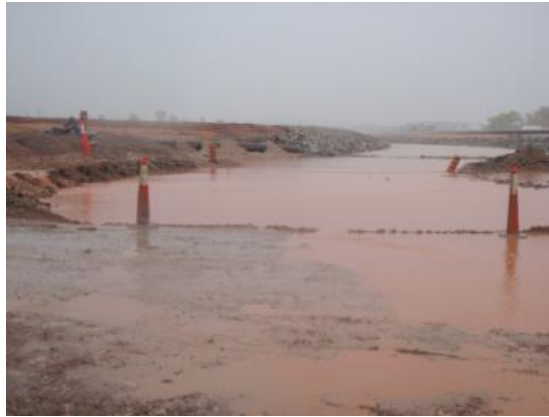
As part of their Sediment and Erosion Control Plan, the TP7 Contractor applies Geoperm, a bonded fibre matrix, to the surface of the clay and topsoil layers to manage erosion shortly after placing materials. During the start of October 2011 Geoperm was not applied to clay surfaces in a timely manner. Widespread soil erosion occurred as a result of heavy rainfall and lack of erosion control on October 5, 2011 (see Photo 4-2). The primary water bodies affected by soil erosion were the east perimeter ditch, the sump near the base of the Phase I access ramp, the Phase I channel, and the Phase II southwest sump. On October 11, 2011 the DE issued RFA-TP7-Sediment Control, stating that the delayed completion of TP7 hydroseeding and/or seed and mulch application, and a lack of proper sediment controls as per the EPP and site drawings, contributed to the soil erosion. The Contractor did not respond to this RFA before the end of the reporting period.

Photo 4-2: Clay-laden Surface Runoff Water Entering the Phase I Channel During Heavy Rainfall

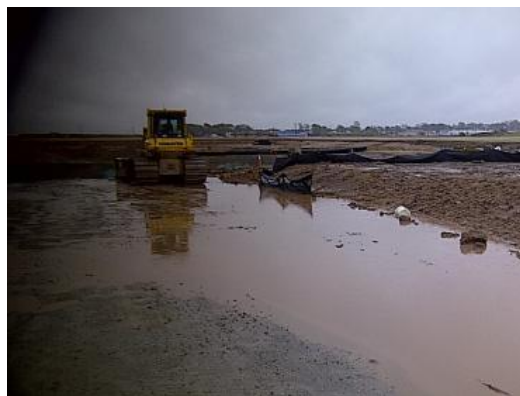
On October 20, 2011 during heavy a rainfall, the DE notified the Contractor that a significant volume of clay-laden turbid water was observed to be draining from the area immediately north of the Phase I clay stockpile (see Photo 4-3). The DE requested that the TP7 Contractor extend their clay stockpile silt fencing so that it extends further north as to provide sediment control during future heavy rainfall events. On October 25, 2011 the Contractor extended this silt fencing. This area did not prove problematic for the remainder of the month.

Photo 4-3: Phase I Clay Stockpile Silt Fencing Prior to Extension

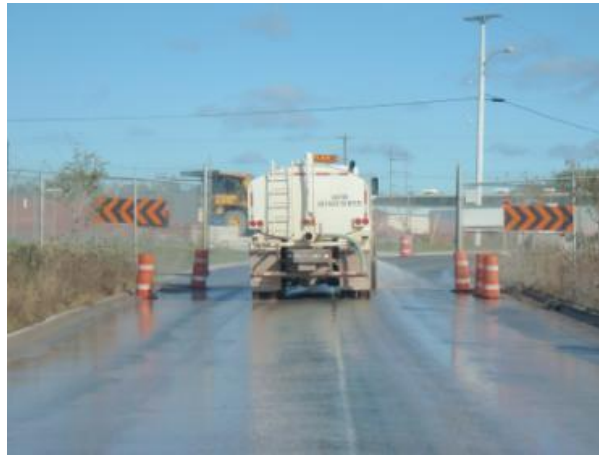
The TP7 Contractor also assured that public roads used by Contractor hauling trucks were swept clean as required. The TP7 Contractor utilized a water truck and street sweeper every work day during October, 2011 (see Photo 4-4). As mentioned in Section 4.3, the Contractor also utilizes filter bags in the catch basins along Inglis street in an effort to capture any TP7 related sediment which may be swept into the basins during street sweeping.

Photo 4-4: TP7 Water Truck Watering Ferry Street Access Road
