REMEDIATION OF THE TAR PONDS AND COKE OVEN SITES

ENVIRONMENTAL MONITORING

SUMMARY REPORT

January 2012 MONTHLY REPORT

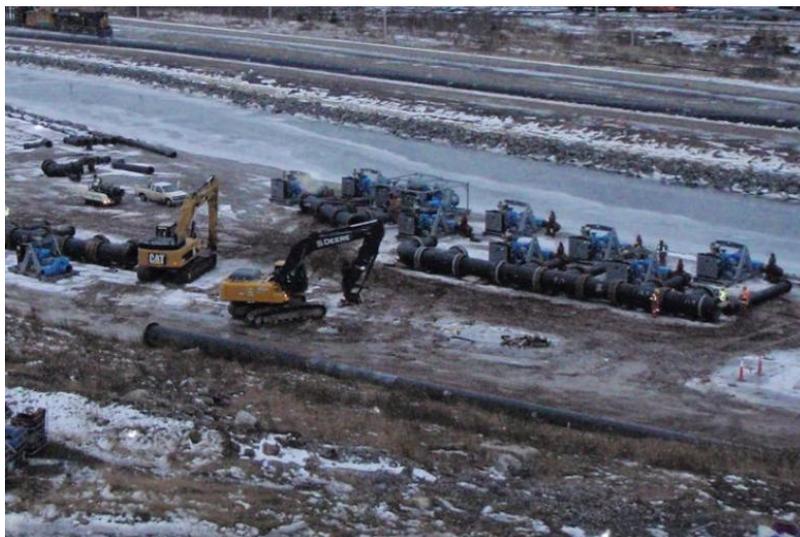
Photo 2-1: Relocation of Pumps from COB to the Narrows Dissipation Structure

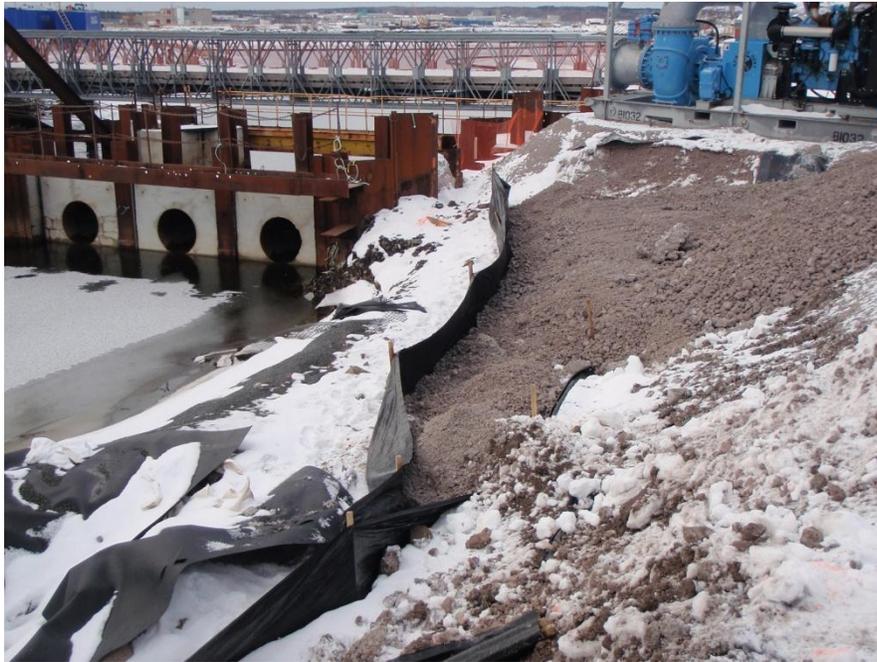
Photo 2-2: New Silt Fencing along the Narrows Pump Pad

Silt curtains which were damaged at Battery Point on December 29, 2011 were replaced on the morning of January 3, 2012. Two (2) new silt curtains were installed between the east and center dolphins at Battery Point on January 3, 2012 as well. A new section of silt fencing was added to the Narrows pump pad on January 10, 2012 (see Photo 2-2). A debris boom was installed in Coke Ovens Brook on January 24, 2012 (see Photo 2-3).

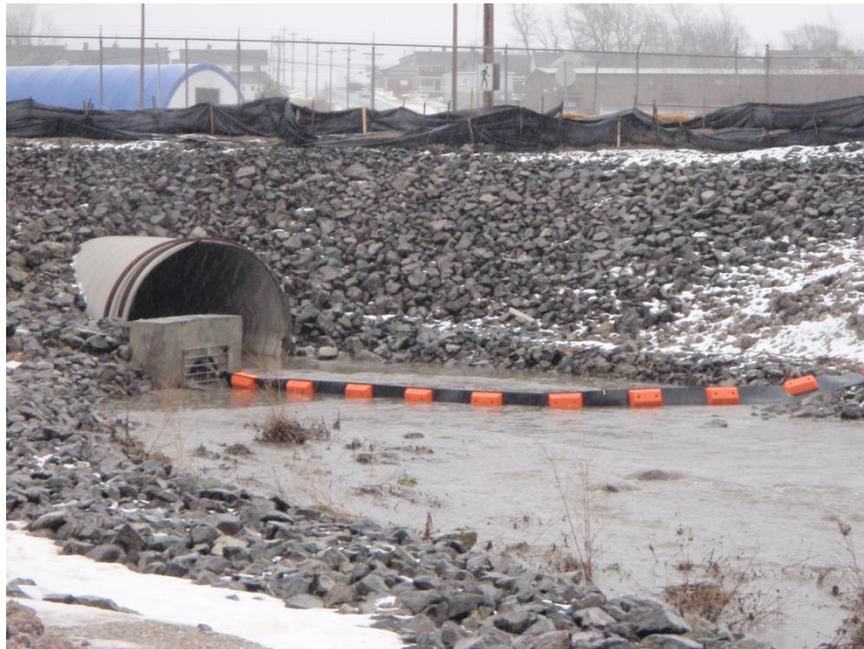
Photo 2-3: New Debris Boom Downstream of Coke Ovens Brook Inglis St. Culvert

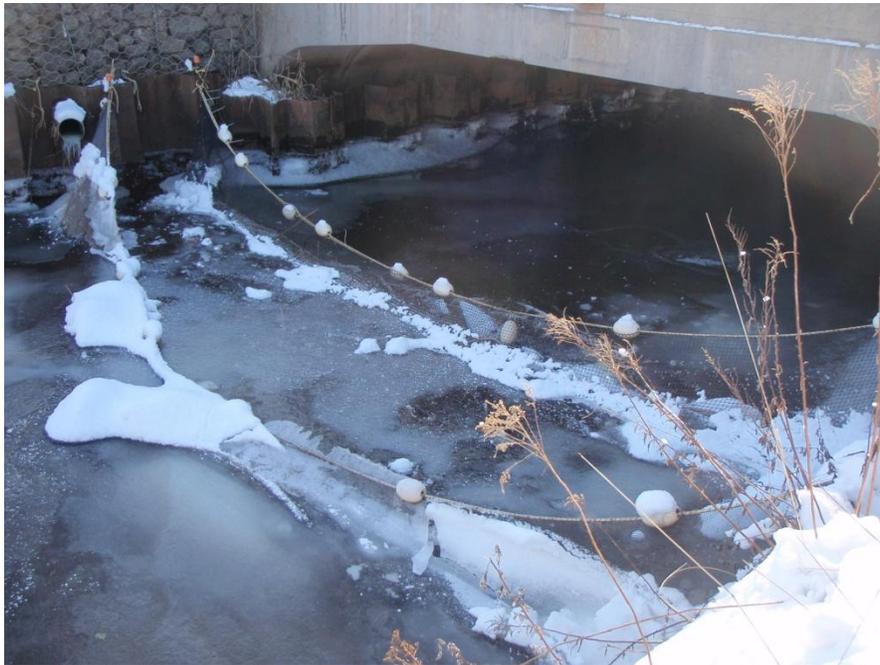
The debris nets at Wash Brook and fish screen at the Inglis Street culvert were cleaned regularly throughout January 2012 to ensure their effectiveness (see Photo 2-4).

Photo 2-4: Fish Nets in Place at Wash Brook
