# REMEDIATION OF THE TAR PONDS AND COKE OVEN SITES

### ENVIRONMENTAL MONITORING

### SUMMARY REPORT

### February 2012 MONTHLY REPORT

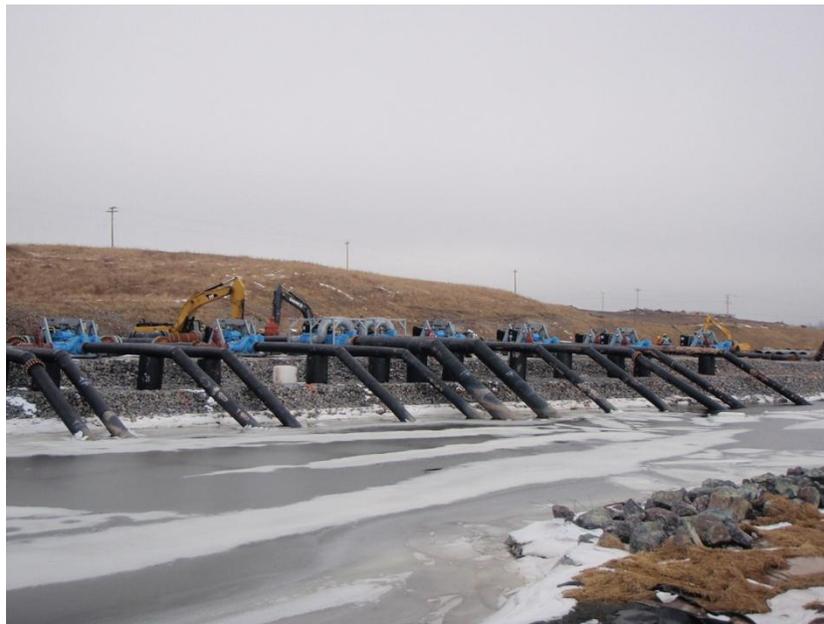
TP6A Contractor construction activities in February 2012 consisted primarily of assembling pipe manifolds at the Narrows pump pad, connecting pump discharge lines to manifolds (see Photo 2-1), transporting pipe sections along the Phase II east access road, fusing 48” pipe along the Phase II east access road, fusing 24” pipe at the Narrows pump pad, transporting pumps and pipe fittings from Coke Oven Brook and Wash Brook, installing a second temporary support and working platform at Battery Point, and fabricating a waler frame for cut-off wall #2 at Battery Point.

Photo 2-1: Newly Relocated Pumps with Suction Lines Installed at the Narrows

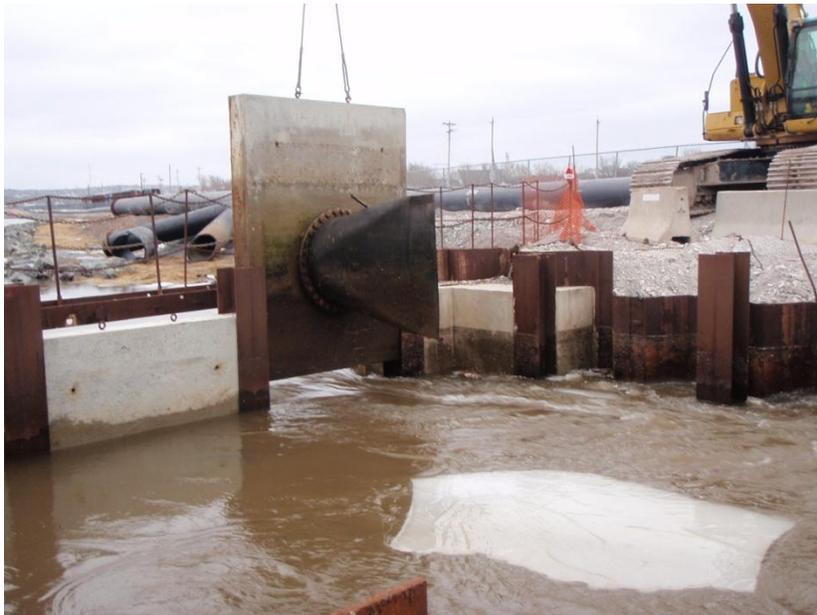
At this point in the project the Wash Brook and Coke Oven Brook pumps have been shut down allowing water to flood the completed channel in Phase I/II. The water then flows through the backflow valves in the Narrows structure and into the Phase III pond. To prevent flooding, the Narrows structure was monitored daily during February, 2012 to ensure functionality of the check valves and note the water elevations. In the event of heavy rainfall and/or higher than normal tides, the contractor is directed by the DE, to raise the stop-logs in the Narrows structure to allow for a greater volume of water to exit the Phase I/II area and reduce the risk of upstream flooding. The TP6A Contractor pulled the Narrows stop-logs for flood mitigation at approximately midnight and lowered them back into place at 18:20 on February 12, 2012 in response to rainfall accumulation of 42.8 mm on February 11, 2012 (see Photo 2-2).

**Photo 2-2: Raised Narrows Stop Log**

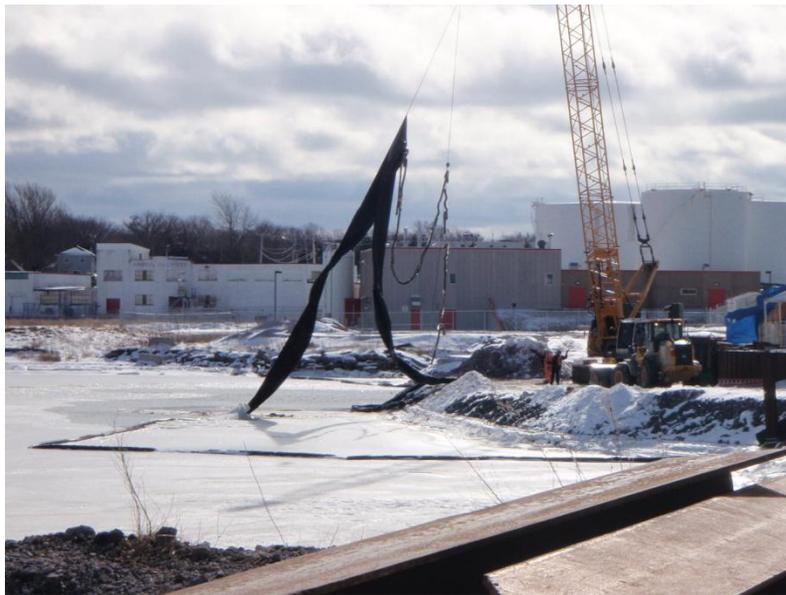
Derelict silt curtains which have been replaced were removed from Battery Point on February 7, 2012 (see Photo 2-3). Silt Fences near the Narrows pump pad were repaired on the afternoon of February 23, 2012. Hay bales and silt fencing were installed along east access road to minimize possible turbidity associated with leaking water from force mains during Phase III hydro testing on February 24, 2012 (see Photo 2-4).

**Photo 2-3: Removing Derelict Silt Curtains from Battery Point Work Area**

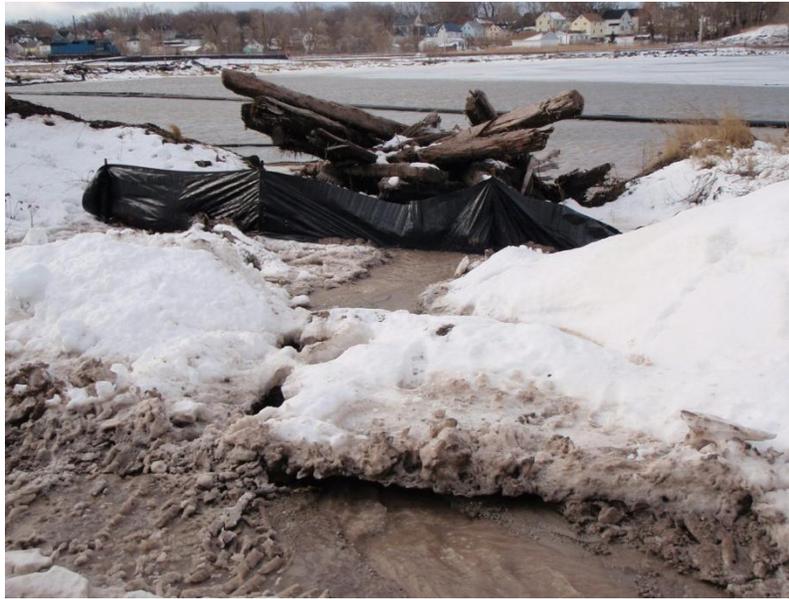
**Photo 2-4: Silt Fencing and Hay Bales Installed Along the East Access Road**

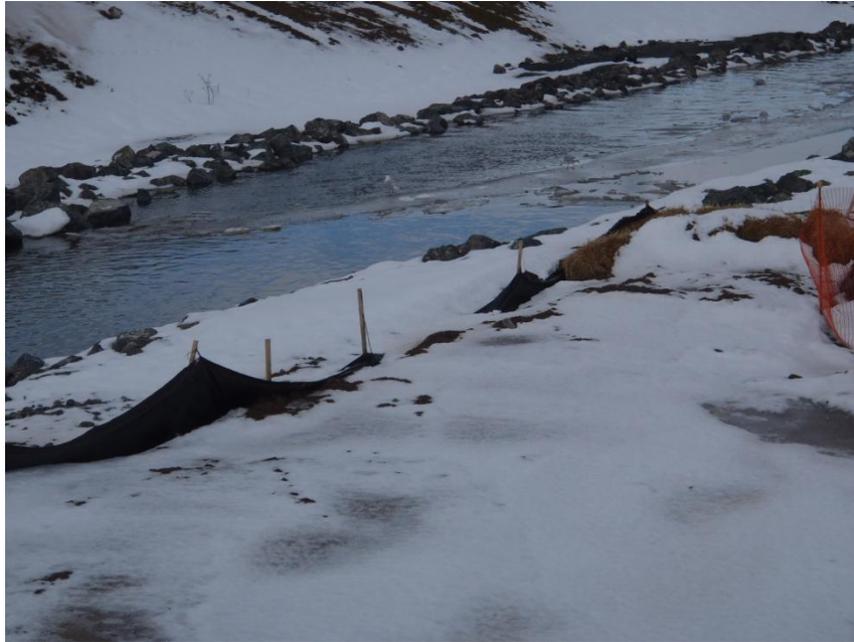
Repairs were made to wind damaged silt fence along main Phase II channel stem on February 3, 2012. Heavy rainfall on February 11, 2012 exposed snow/wind damaged sections of silt fencing along the west side of the receiving pit and the east side of the main channel (see Photo 4-1). The TP7 Contractor made repairs to the damaged sections of silt fencing and added hay bales to reinforce broken or loose steaks on February 15, 2012 (see Photo 4-2). On February 16 and 24, 2012 the TP7 Contractor made repairs to

**Photo 4-1: Example of TP7 Environmental Controls Damaged by Winter Weather**

berms which had been damaged during the heavy rainfall which fell on February 11, 2012. Additional repairs were made to snow damaged silt fencing on February 23 and 27, 2012.

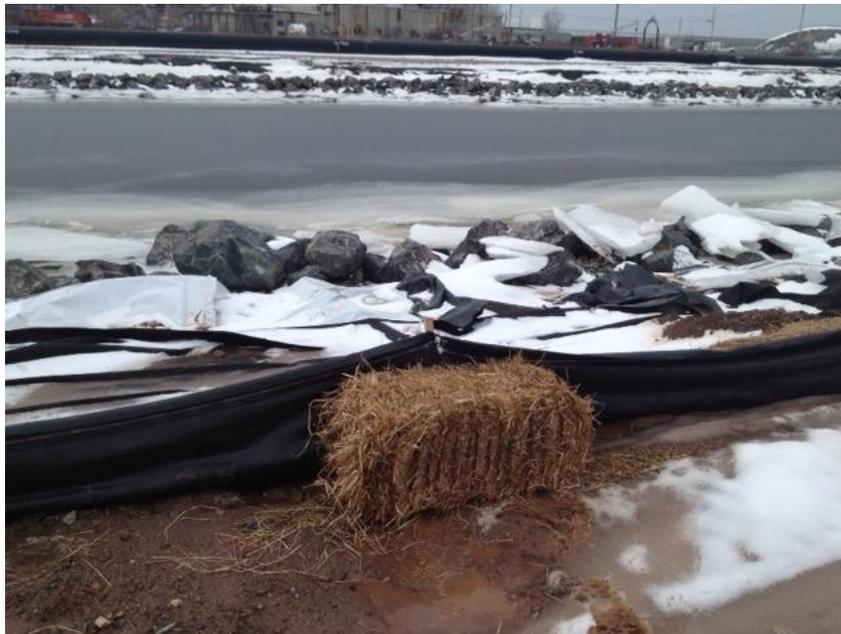
**Photo 4-2: Hay Bales Installed during Repair Efforts**
